**THE GAP BETWEEN VEHICLE AND PLATFORM AS A BARRIER FOR THE  
DISABLED; AN EFFORT TO EMPIRICALLY RELATE THE GAP SIZE TO THE  
DIFFICULTY OF BRIDGING IT**

Delft University of Technology

Faculty of Civil Engineering and Geosciences

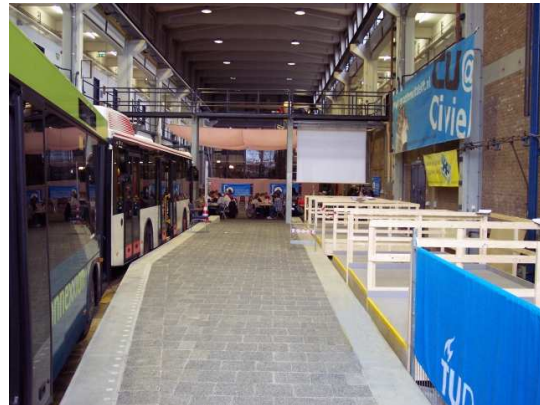
**Figure 1: Overview of the laboratory set up from the ground floor.**

In the TU Delft Transport Laboratory a testing site has been constructed. The city of The Hague provided the materials for copying a platform of its new Randstadrail (new light rail network) rail/bus stops. Overviews of the laboratory set up are shown in Figure 1 and Figure 2.

At one side of the platform, five wooden platforms have been erected at different combinations of horizontal and vertical distance, shown in Table 1. The closest platform, 2x2cm, represents the standard for Dutch elevators. The widest gap, 10x10cm, represents the acknowledged maximum value. A gap of 12x3cm gap was included,

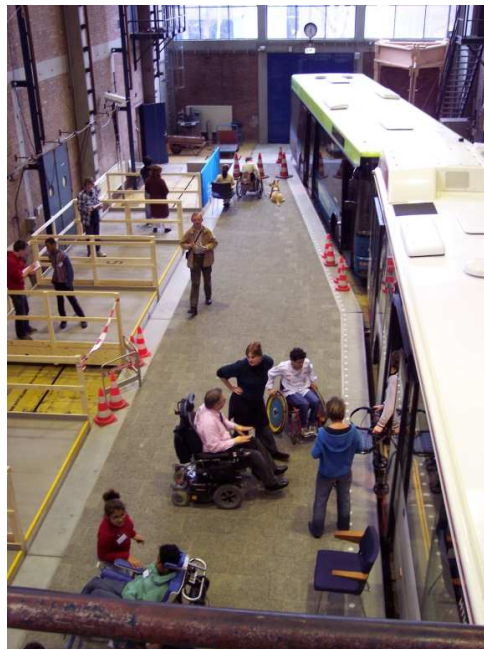
**Figure 2: Overview of the laboratory set up from a higher point of view.**

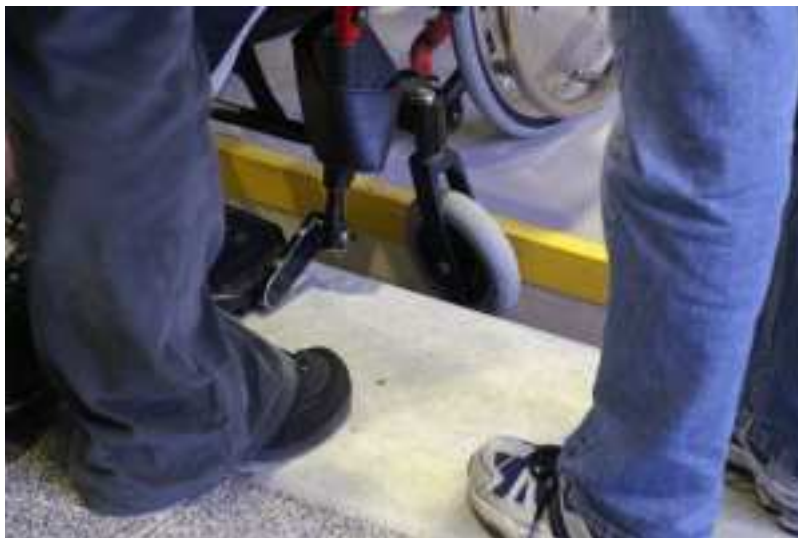
**Figure 3: People got stuck in gaps...**

It was remarkable to see with how much enthusiasm people participated in the test. We saw no signs at all of reluctance in the efforts to cross the barriers. The participants sooner seemed to want to show how much they could achieve. It implied that several people got stuck in gaps (with the small swivelling wheels of a wheelchair, see Figure 3), people cut capers (see Figure 4), wheels broke off sometimes and upsetting of vehicles could be prevented with difficulty only.

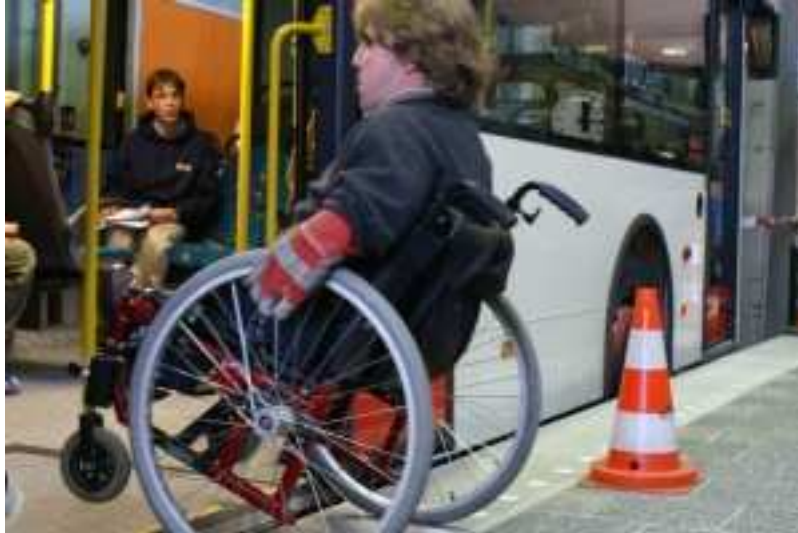
**Figure 4: With some capers, people in wheelchairs succeeded in boarding the bus at a 12x3cm gap from the platform.**

The results for all gaps are compared for electrical wheelchairs and for scoot mobiles (Figure 6). The problems for electrical wheelchairs are building up gradually, whereas those for scoot mobiles are present only at gaps that are both wide and high. The forward speed is no longer sufficient to get the wheels with a diameter of about 20cm across the gap. Some of the hand wheelchair users still manage, because these can lift up the small front wheels and develop sufficient speed for the large rear wheels to cross the gap (see Figure 4). This does however require a well developed musculature.

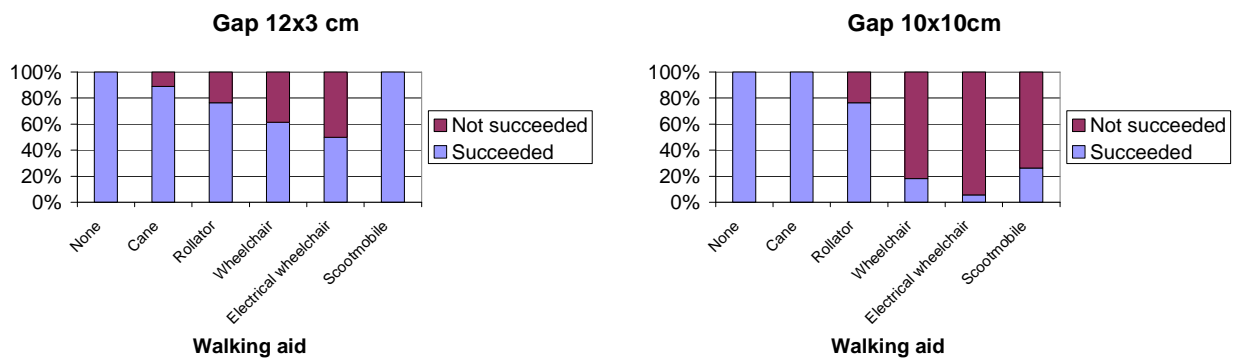
**Figure 5: Results of the two largest gaps for people using different walking aids.**

We will present the outcomes in two ways: per gap and per walking aid. This way, one can see both which types of users are lost when the gap widens, and how losses in a single user type increase. The results for the largest gaps are shown in Figure 5.

- The smallest gap, with the ideal measures of 2x2cm, proves to be ideal indeed: none of the participants failed to cross it.
- The 'metrogap' of 5x2cm was a problem only for a single wheelchair user.
- The 5x5cm gap, qualified as acceptable for wheelchair users in several manuals, proved to be problem for about one third of both hand wheelchair users and electrical wheelchair users. This confirms the outcomes of British research mentioned before.

- The 12x3cm gap was an obstacle for about half the number of electrical wheelchairs and for smaller portions of other aid categories with the exception of the scoot mobiles which have relatively large wheels which do not swivel.
- The 10x10cm proves to be disastrous for all wheelchairs as well as scoot mobiles. Rollator users can often manage still, at least without a full shopping basket (!).
